# DEPARTMENT OF HOMELAND SECURITY

Customs and Border Protection

## Other Incident Investigation Investigation Report

Investigation into the line of duty death of SPA Luis A. Aguilar (YUM/YUS)

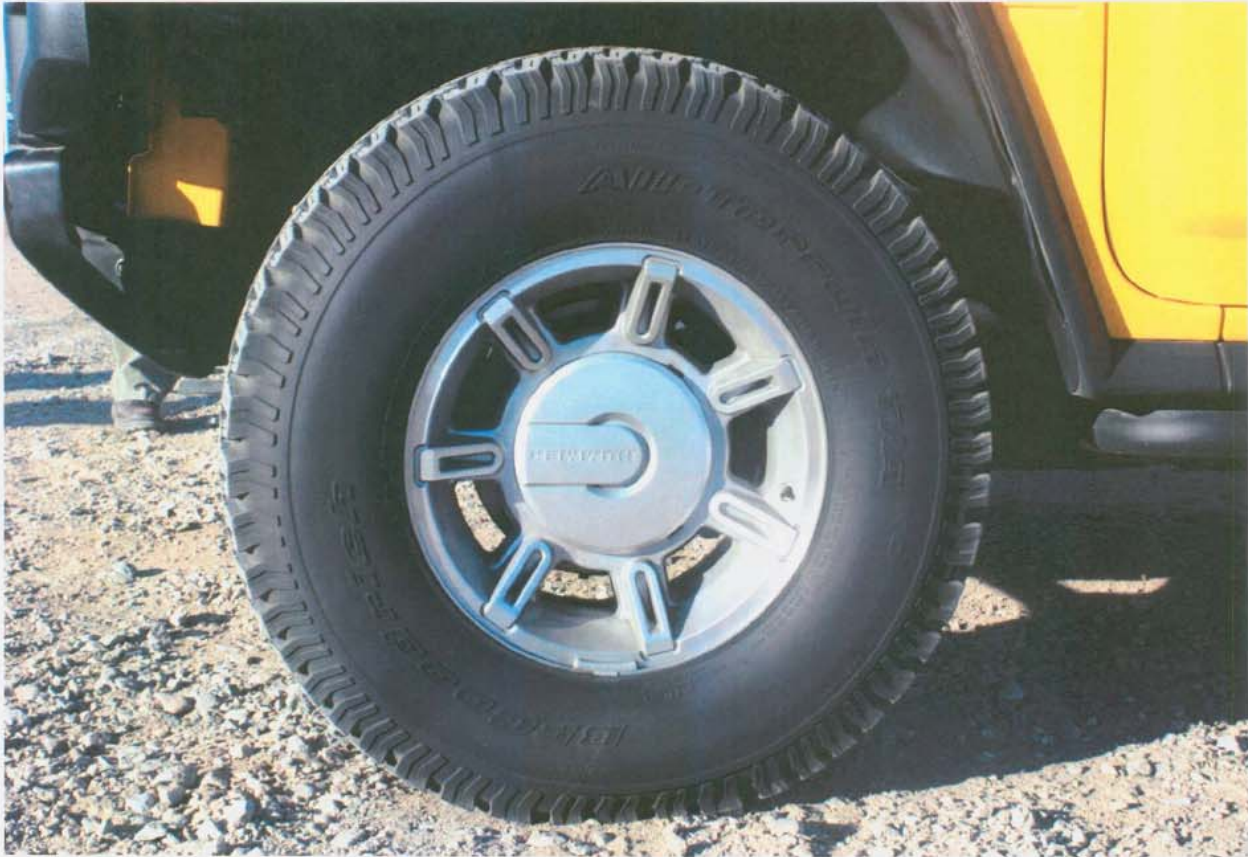
Digital Photograph 106 of 113

Description: BF Goodrich All-Terrain T/A (LT315/70R17 D) factory stock tires on 2003 H2 Hummer.

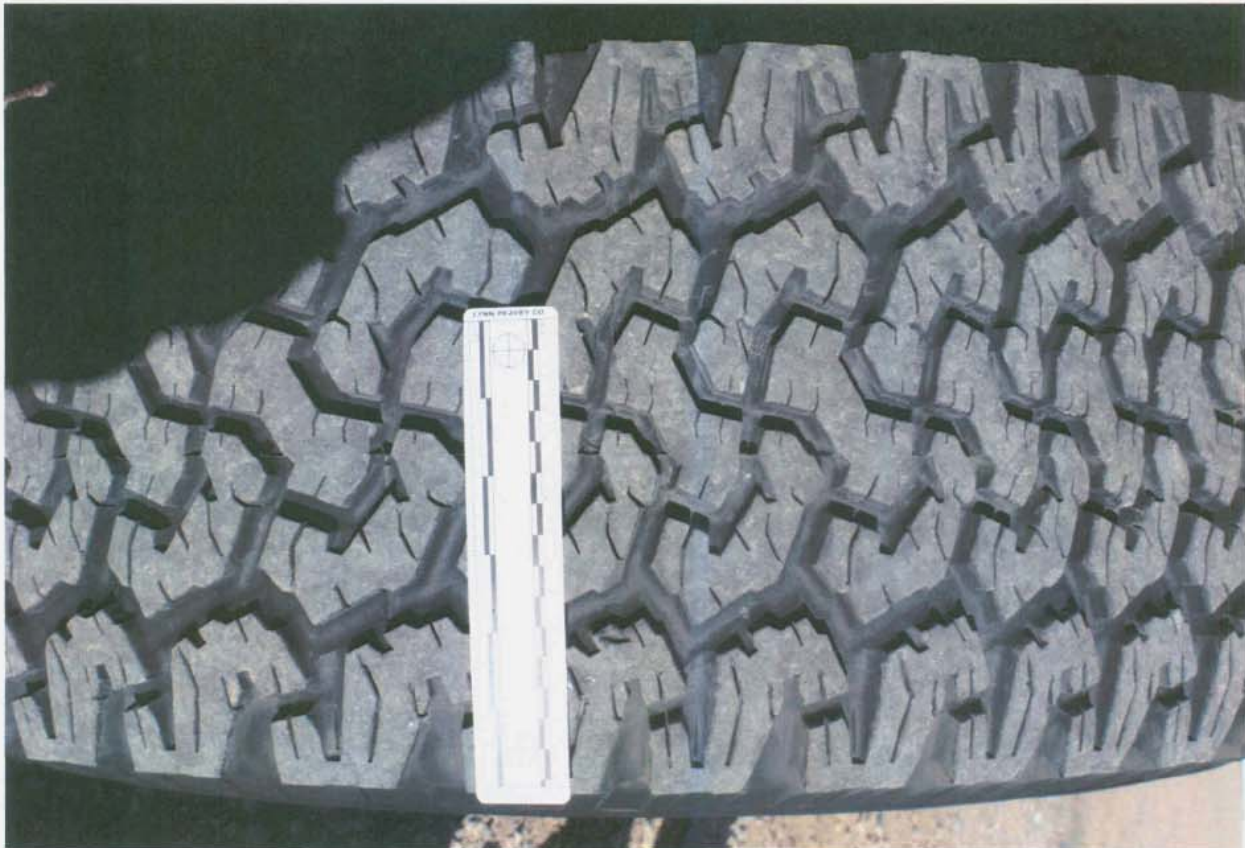
Digital Photograph 107 of 113

Description: BF Goodrich All-Terrain T/A (LT315/70R17 D) factory stock tires on 2003 H2 Hummer.

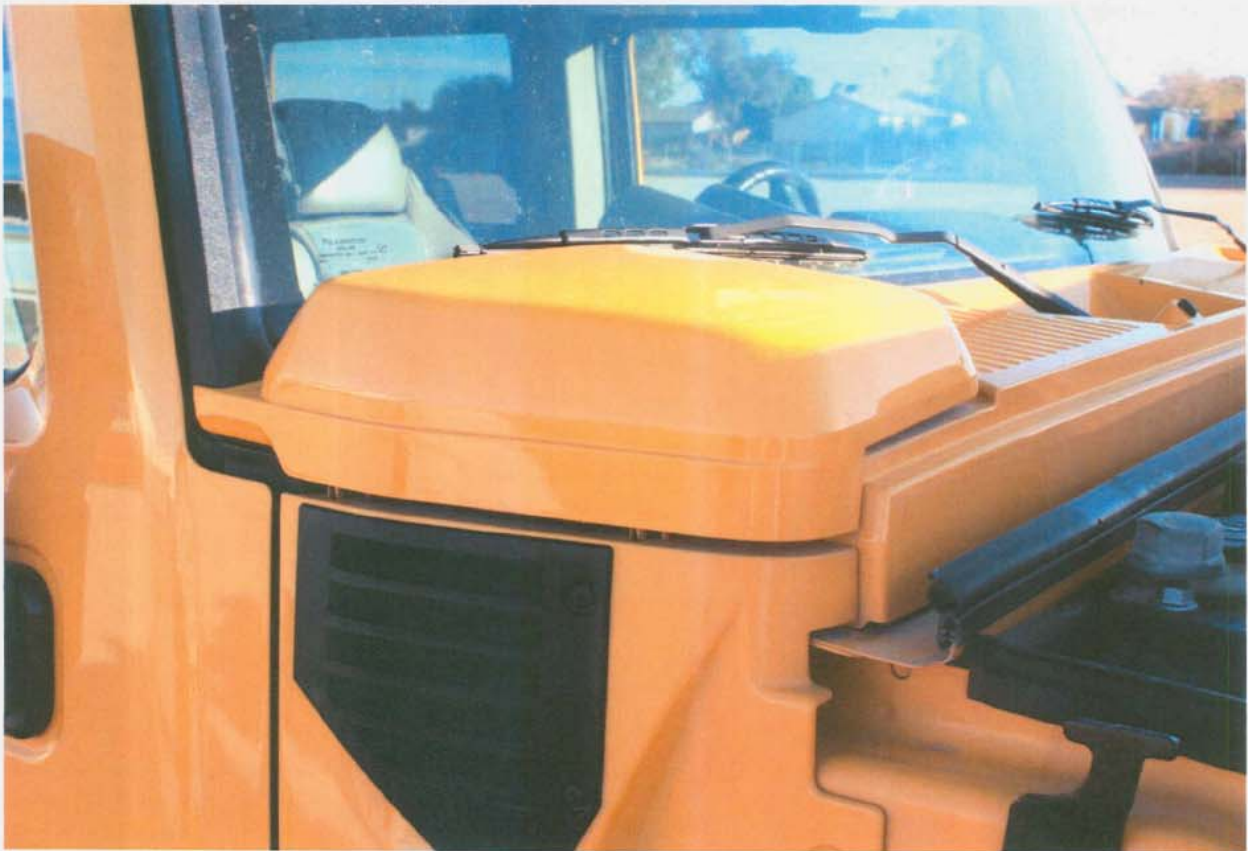
Digital Photograph 109 of 113

Description: Location of air intake covers in relation to the hood and front windshield.

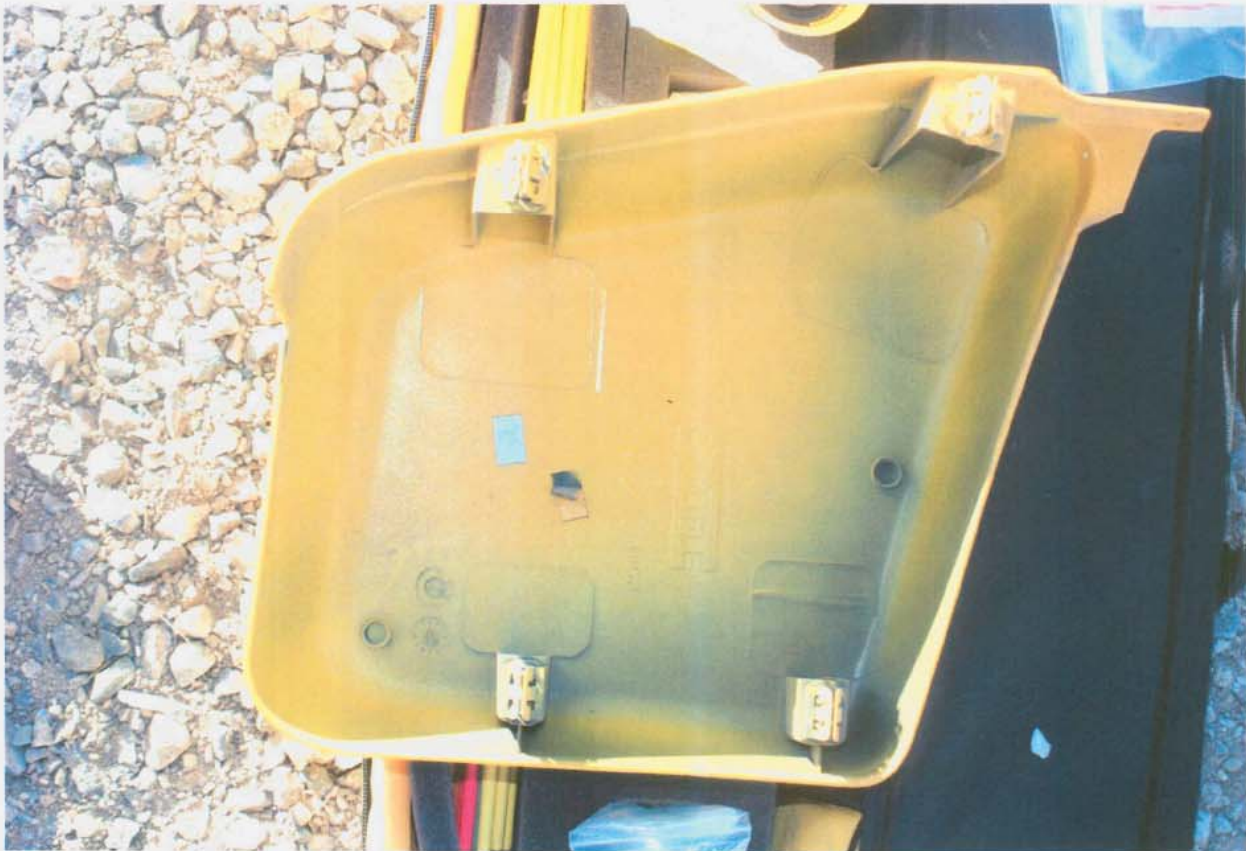
Digital Photograph 110 of 113

Description: Interior of air intake cover to 2003 H2 Hummer.

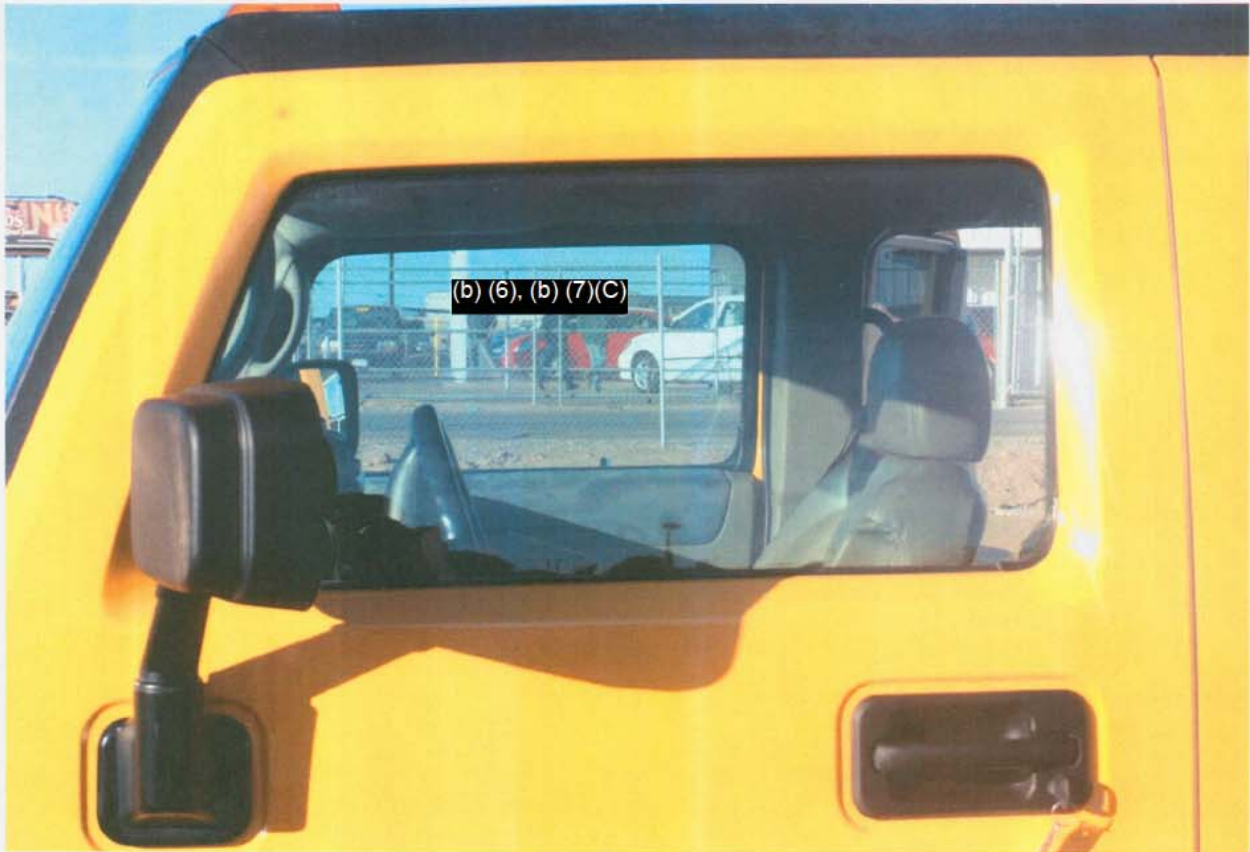
Digital Photograph 111 of 113

Description: Stock window treatment of 2003 H2 Hummer.

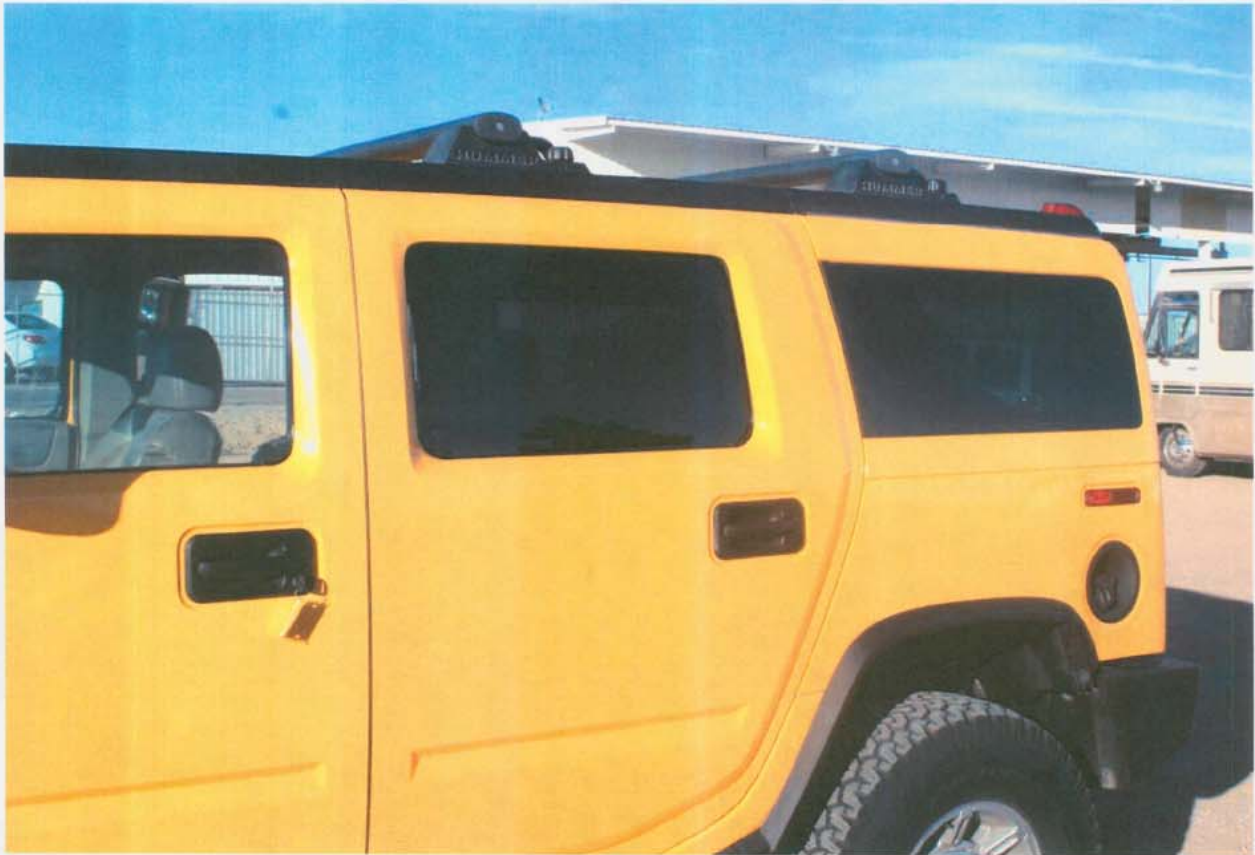
Digital Photograph 112 of 113

Description: Stock window treatment to rear windows on 2003 H2 Hummer.

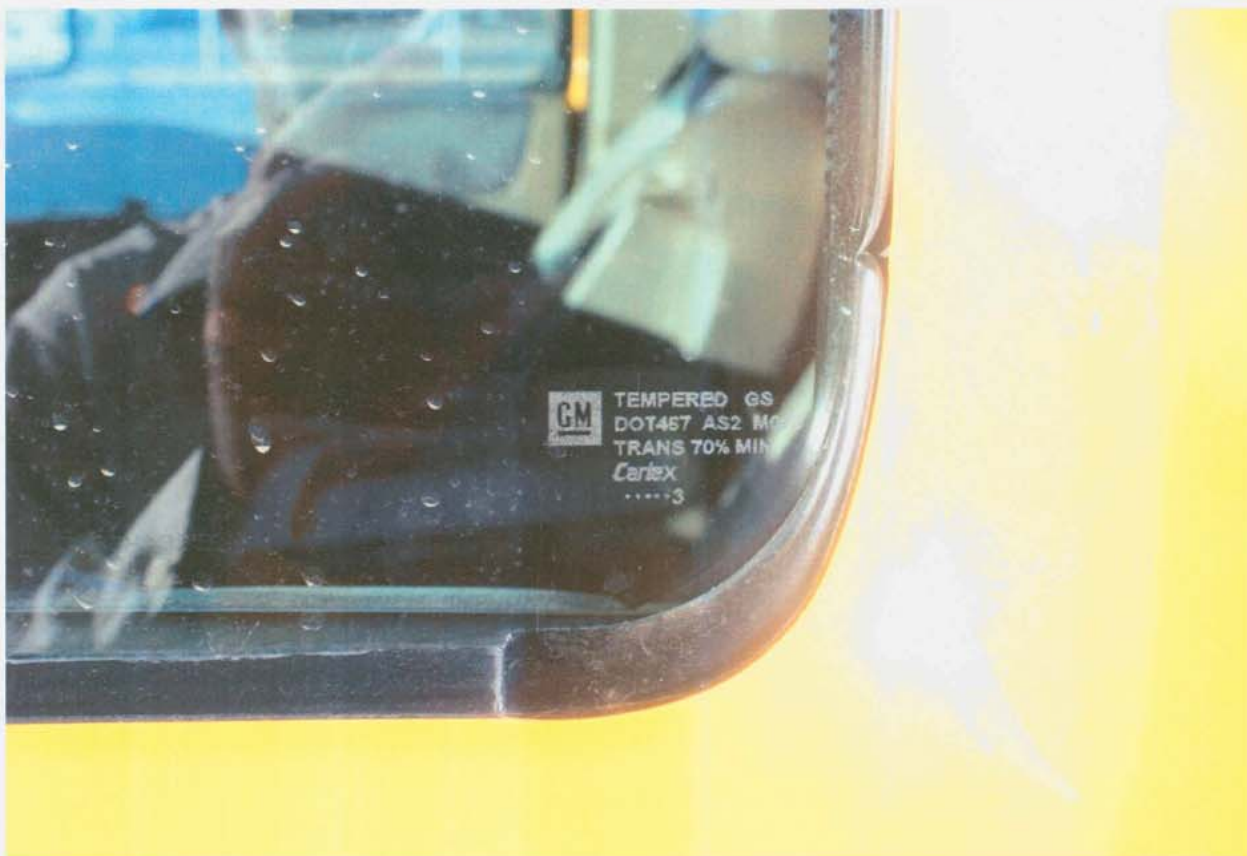
Digital Photograph 113 of 113

Description: Stock tempered window glass on front doors. Transparency of 70% Minimum.
